Manhole Inspection Summary

Manhole # S53M__044MH

Location Address: **3200 hudson**

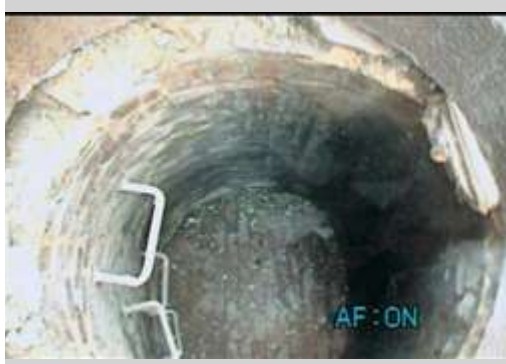
Defect 1

Condition: ☐ Sound ☐ Cracked ☐ Root Intrusion ☒ **Loose Brick** ☐ Deteriorated

Steps Count: **4** Missing: **0** ☒ **Corroded**

Loose bricks in Chimney, Corroded Steps

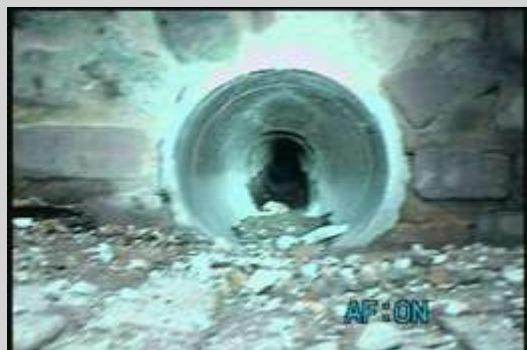
12 O'Clock Outflow

8 in. Circular Gravity Sewer
Pipe Out @ 12 O'Clock

Invert Depth: **9.30** (ft.) Flow Characteristics: **Slow**

Infiltration: **None** Pipe Seal Cond: **Unknown**
